A Comparative Field Study of Permastripe™ Polymer Concrete and Waterborne Airfield Pavement Markings

J. Kent Newman, Donna Speidel, Ron Boeger, and Betsy Hudson

June 2007

Final report

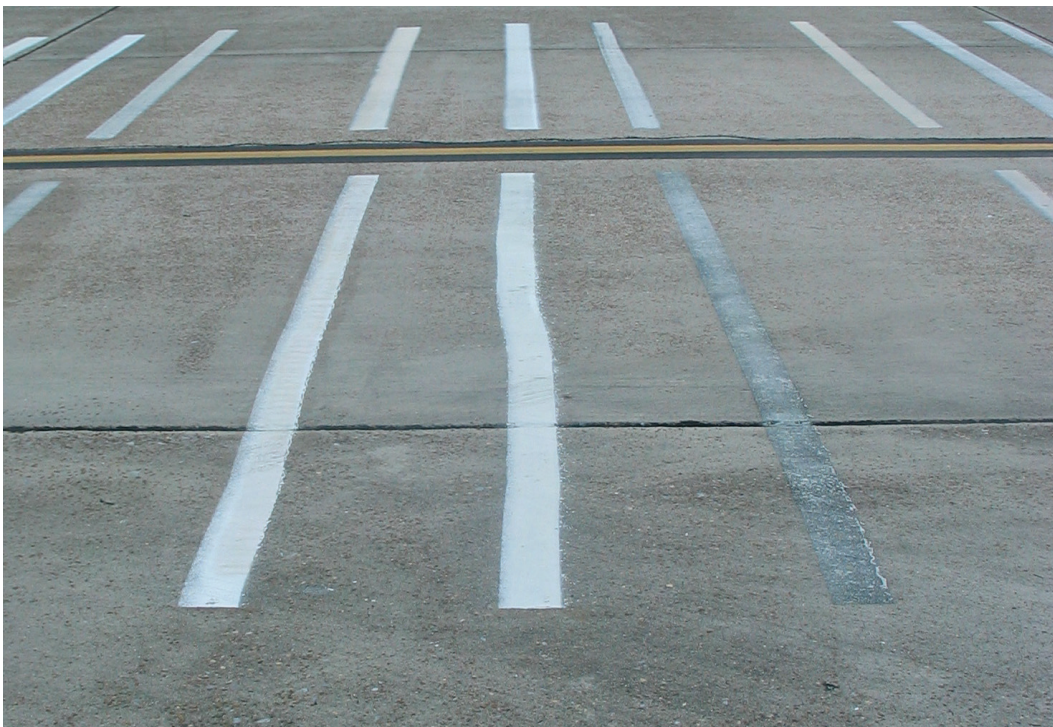
Figure 2. Soiling of PermaStripe™ line from test 2 at Tyndall AFB.

The PermaStripe™ material displayed a tendency to harbor algae, resulting in a splotchy appearance (Figure 2). The retroreflectivity of the PermaStripe™ compared to paint was significantly lower. The low retroreflectivities were due in part to a more rapid curing of the PermaStripe™ during placement compared to what had been observed in test trials in preparation for Test 2. This rapid curing led to low bead density and shallow embedment. Strict control over PermaStripe™ base materials, viscosity, and proper application equipment will allow for better control of line thickness, bead embedment, and curing rates. The differences in retroreflectivity of the different bead types in PermaStripe™ and paint were evident. As expected, the Type III beads resulted in higher initial and final retroreflectivities, but lost a higher percentage of the initial retroreflectivity than either Type I or the Brite Blend™ Type I/Type III blend.

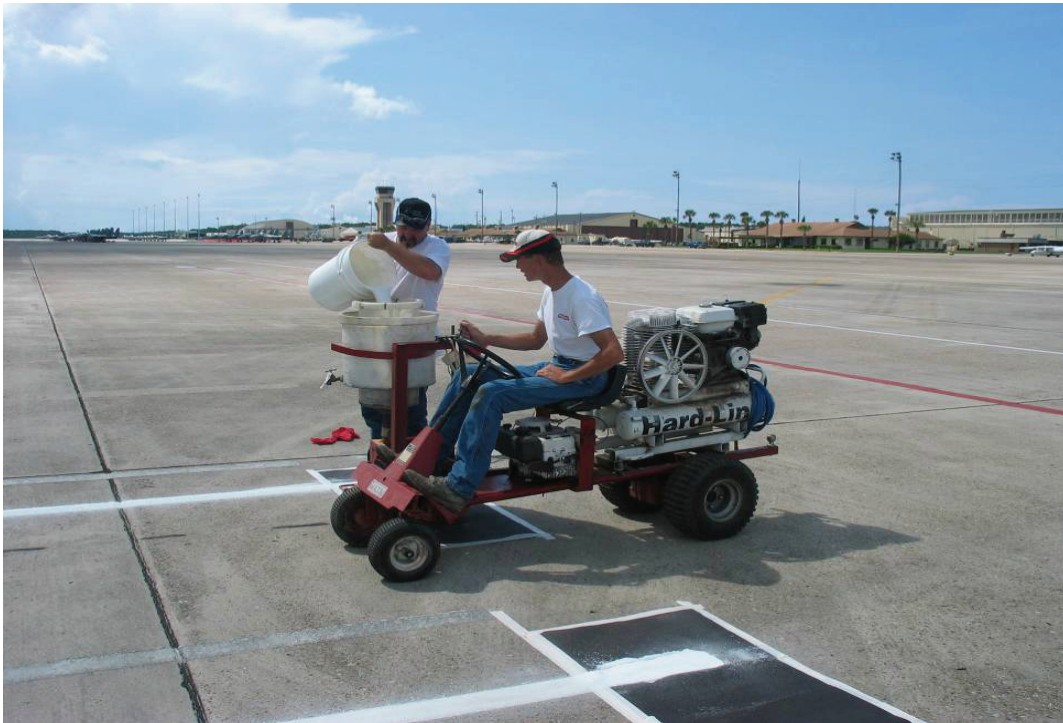
Figure 4. Prototype of the Hardliner™; application device for PermaStripe™.

PermaStripe™ placement was much improved over that in Test 1, but still suffered from a lack of control over viscosity and application conditions. The PermaStripe™ prototype applicator employed a modified drywall texture application device mounted to a self-propelled lawn mower (Figure 4). This resulted in acceptable PermaStripe™ line thickness (25 to 30 mils). However, bead embedment was inconsistent due to rapid curing of the PermaStripe™ that was not observed in test trials run in preparation for Test 2. This required changing the bead applicator during the test. The original bead applicator used a gravity drop and was switched to a Potter Industries dispenser. The paint was applied using a standard walk-behind gas-powered spray device equipped with a Potters Industries retroreflective bead dispenser (Figure 5). No masking was used.

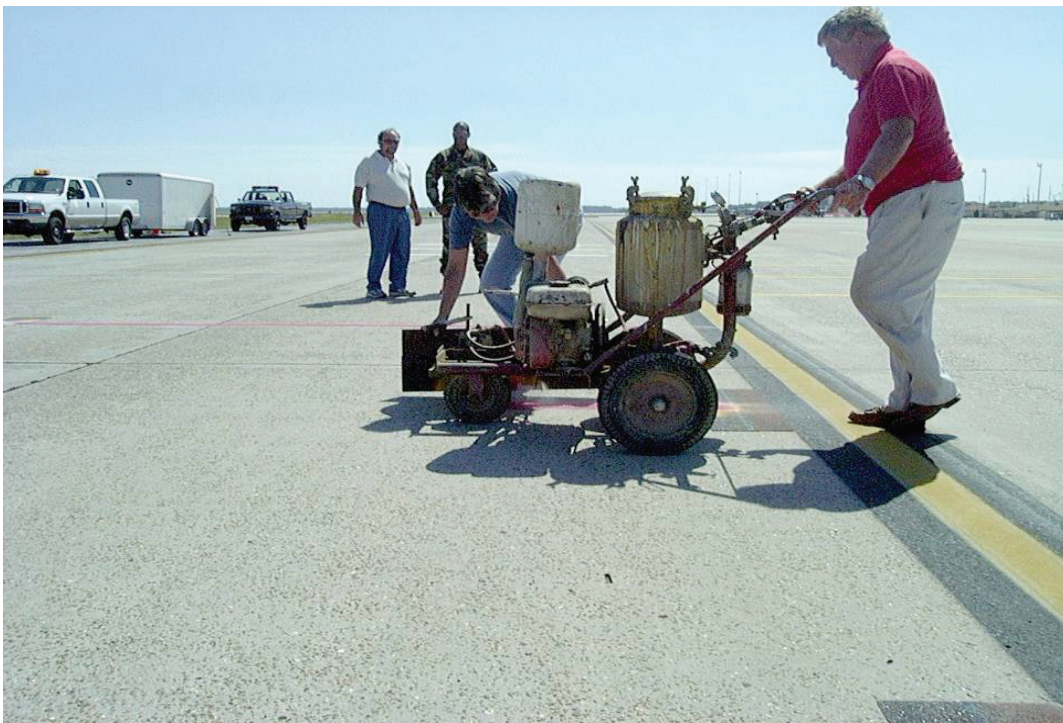
Figure 5. Paint striping machine used in Test 2 and Test 3 at Tyndall AFB.

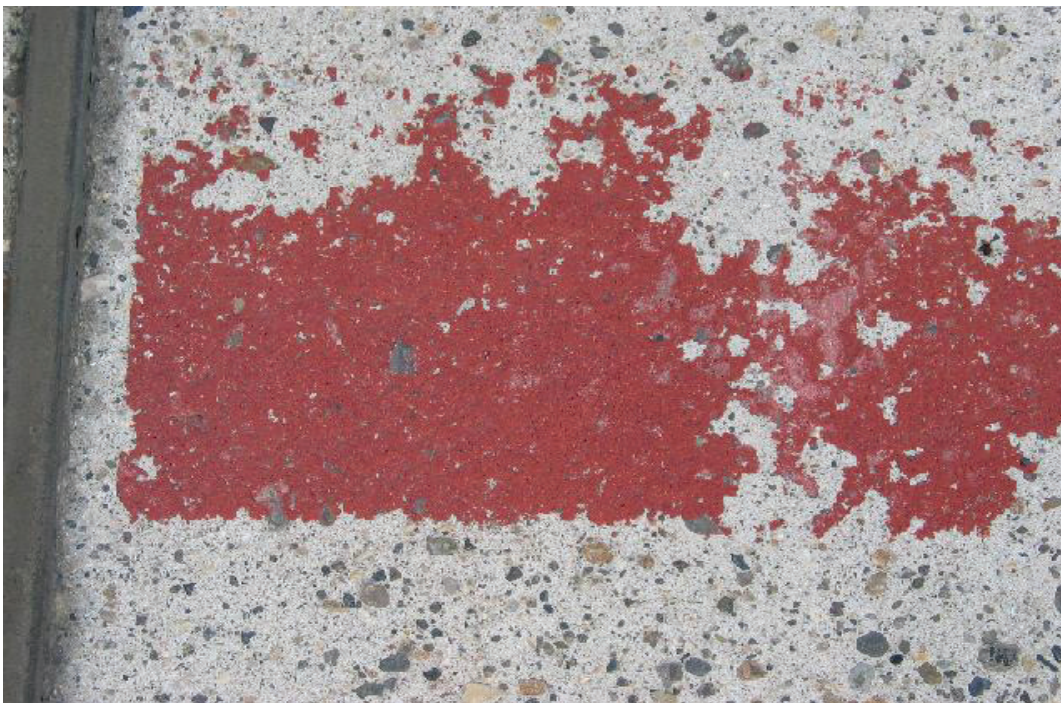
Figure 26. Severe delamination of the PermaStripe™ markings at Mountain Home AFB.

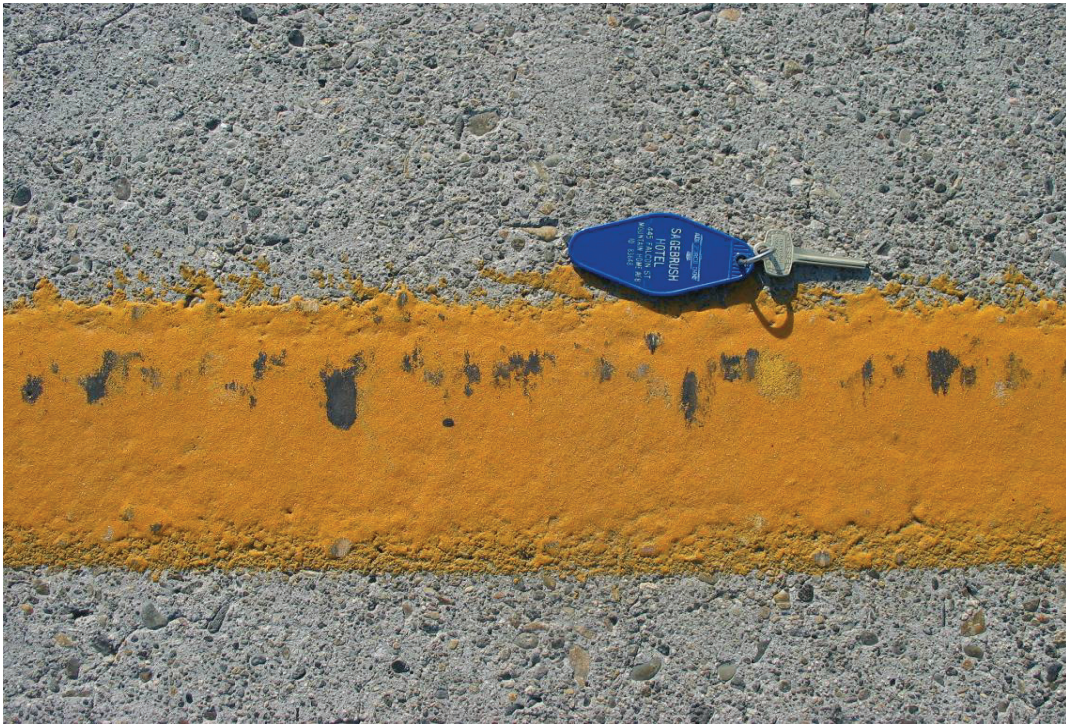
Figure 27. Staining of PermaStripe™ markings at Mountain Home AFB.

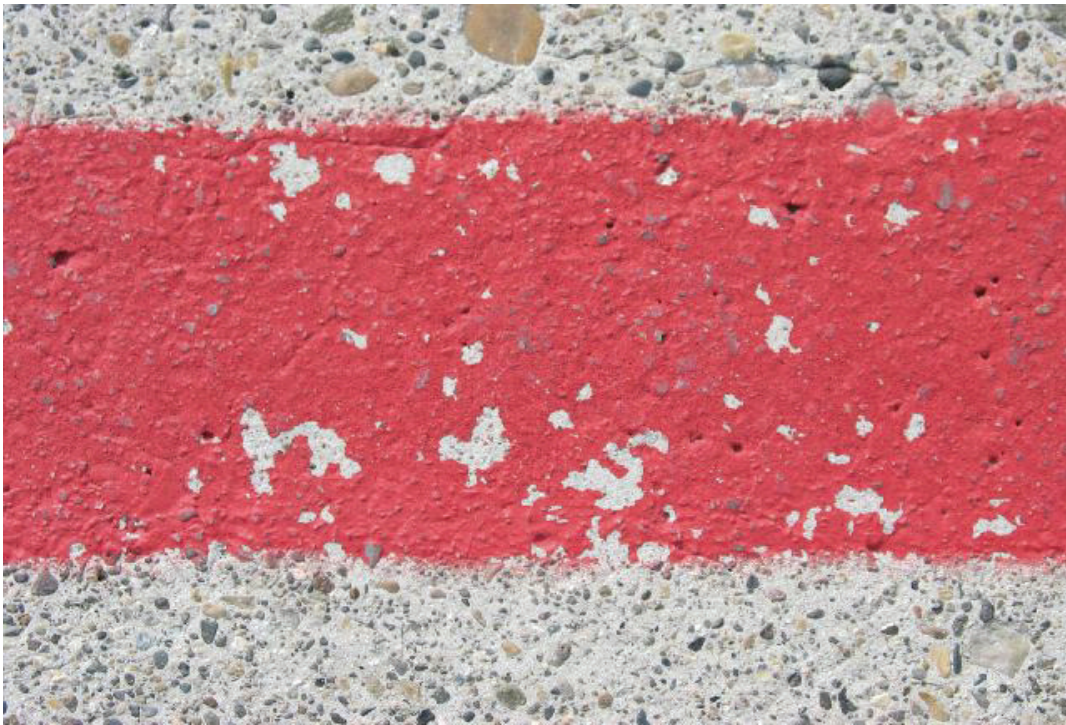
Figure 28. Severe delamination of paint markings at Mountain Home AFB.
